Aquatic Resources Delineation Report -
Tuolumne Facility

Forest Resiliency Program - Tuolumne Facility

Tuolumne County, California

SEPTEMBER 2023

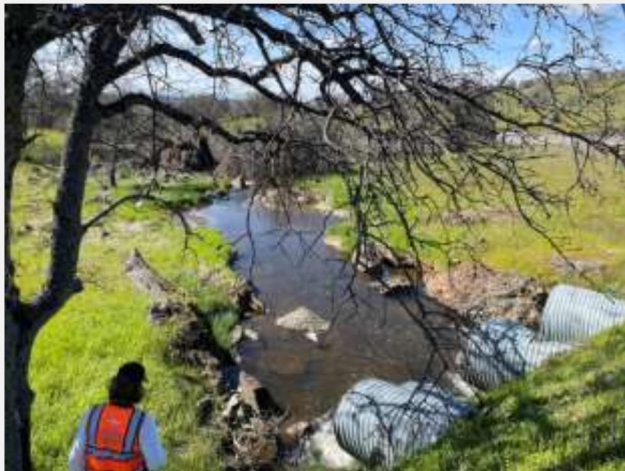
PP-05. View facing east of ID-01 in the northern parcel of the study area.

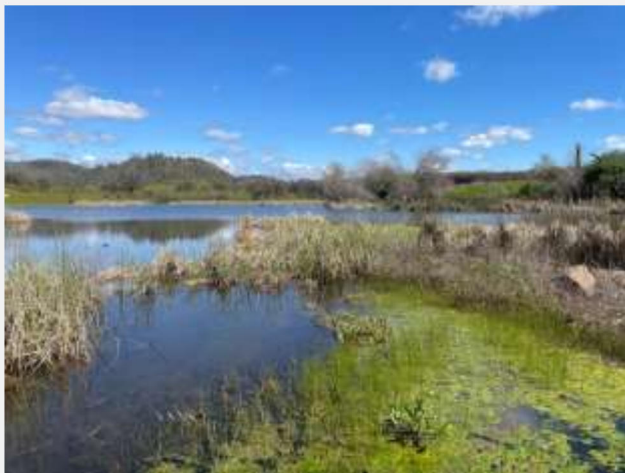
PP-07. View facing east of feature P-01 in the north and northeastern portion of the study area.

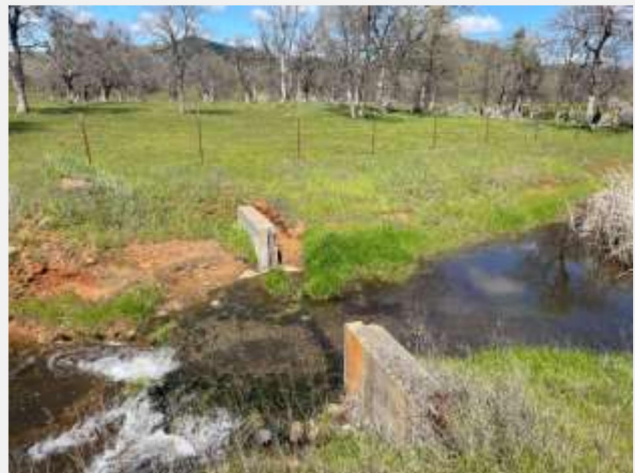
PP-08. View facing east of feature P-01 in the north and northeastern portion of the study area.

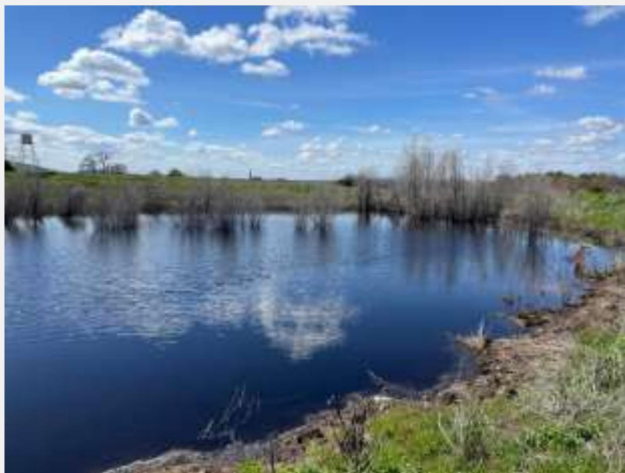
PP-11. View facing west of DB-02 along the eastern boundary.

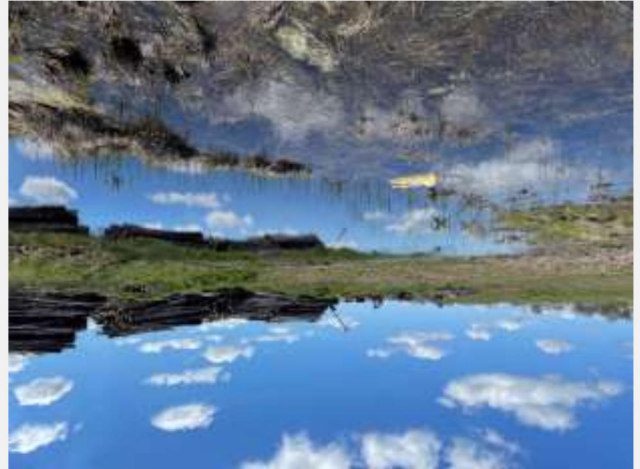
PP-16. View facing southwest adjacent to DB-03.

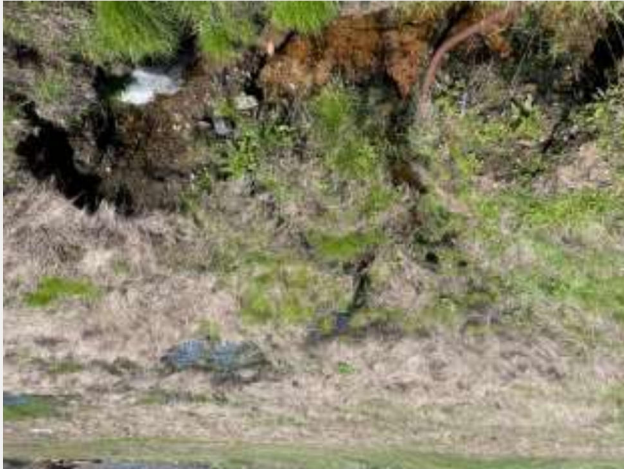
PP-13. View facing southeast of feature DIT-02.

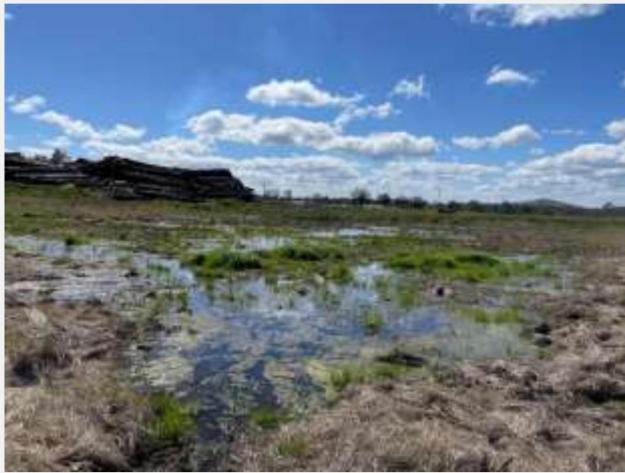
PP-17. View facing southeast of feature DB-03.

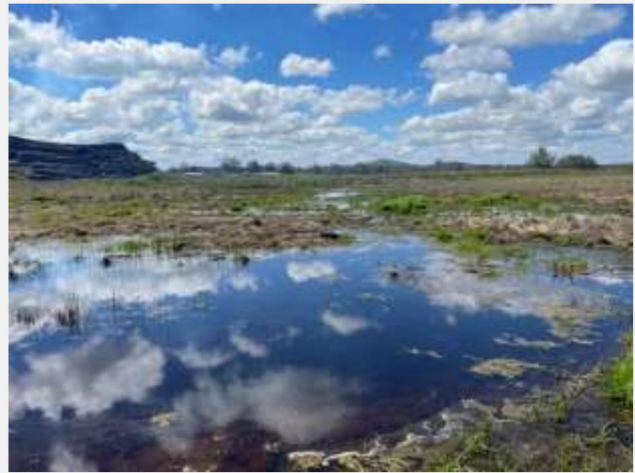
PP-18. View facing south of DB-03.

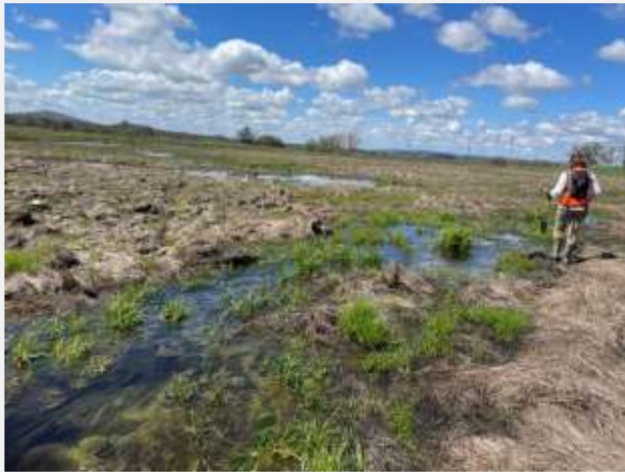
PP-19. View facing east of feature US-02.

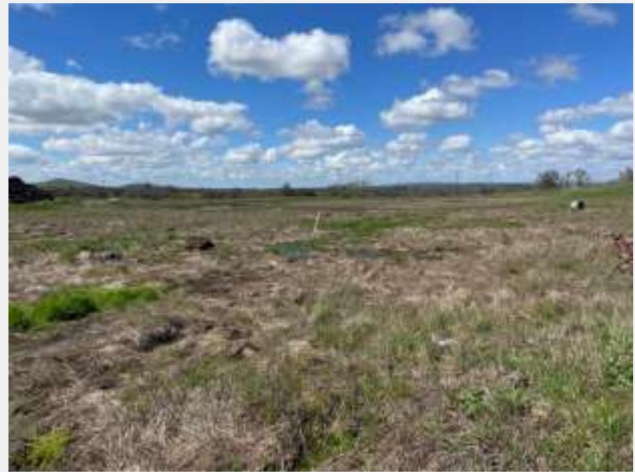
PP-20. View facing east of feature SW-03.

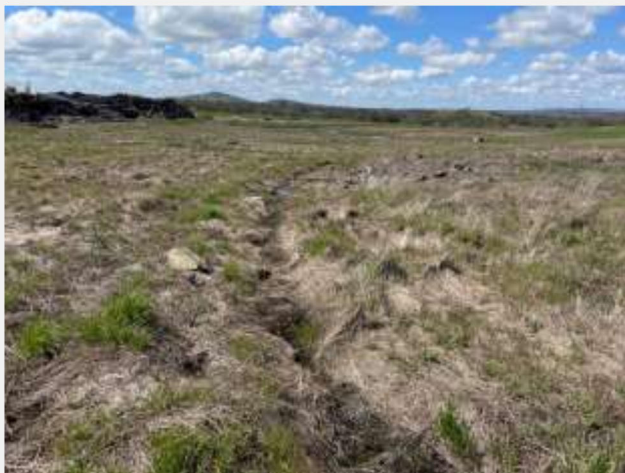
PP-21. View facing south of US-01.

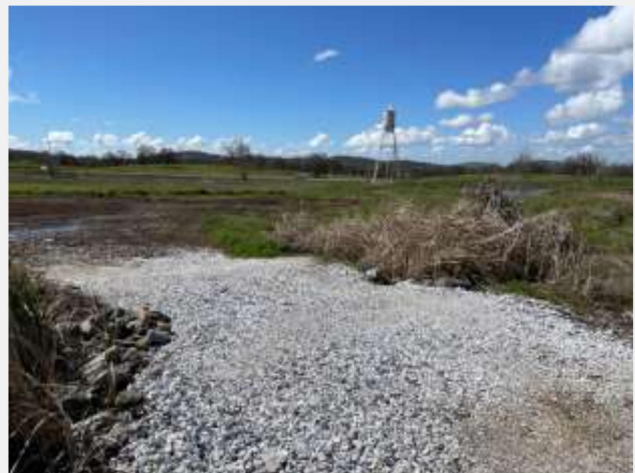
PP-22. View facing southeast just south of the concrete lot facing PD-01 in the southeastern portion of the project.

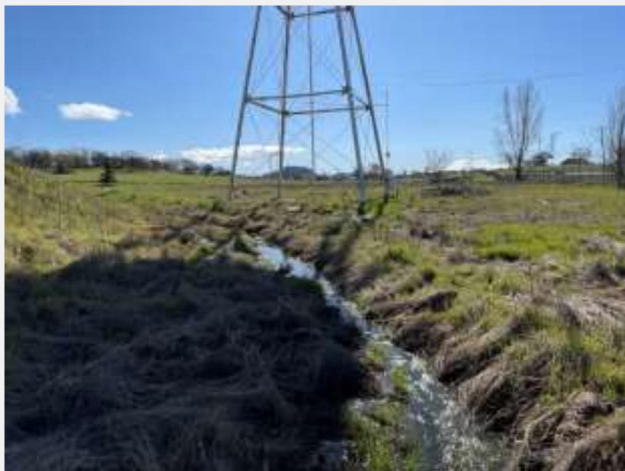
PP-23. View facing southeast of DIT-01 in the southwestern portion of the study area.

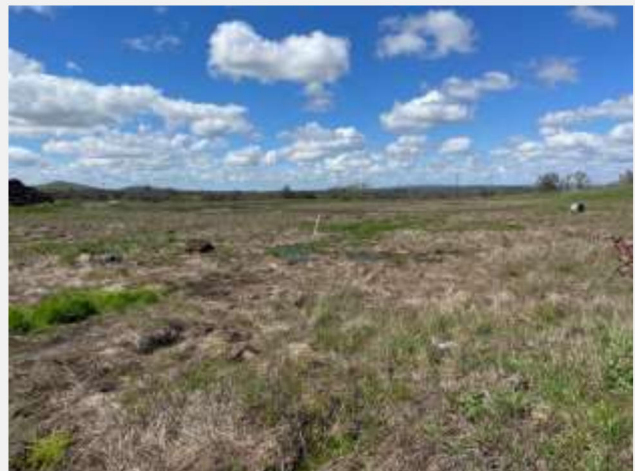
PP-24. View facing east of feature SW-03.
